# North Mesa Brewer Arena Assessment

Los Alamos, NM

# Existing Conditions Assessment

## North Mesa Brewer Arena

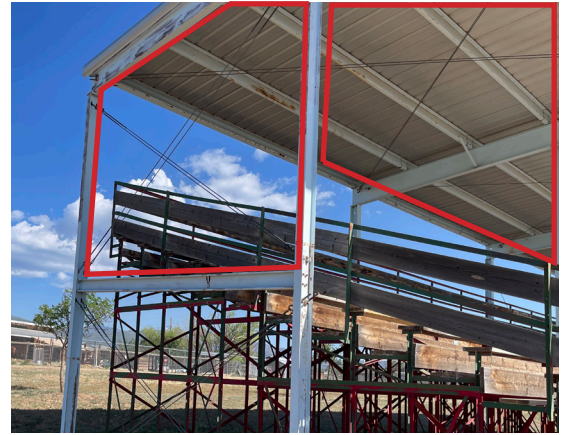
The Pavilion structure's cross bracing cables have been installed incorrectly and are currently slack. They won't function properly unless installed with turn buckles to allow for tightening and loosening based on ambient temperature.

View of Pavilion cross bracing

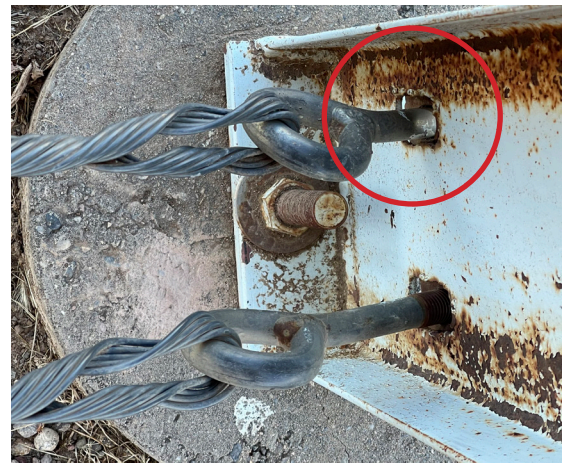
It appears that the cable bracing eye bolts are installed through torch cut holes. These holes should not be torch cut, but should have been machined in the steel shop.

View of cable bracing

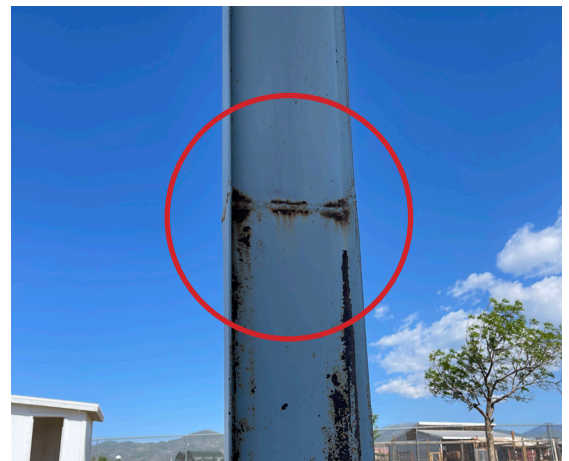
Column welds seen throughout the pavillion structure indicate modification of original site columns when assembled in the current site.

View of column welds

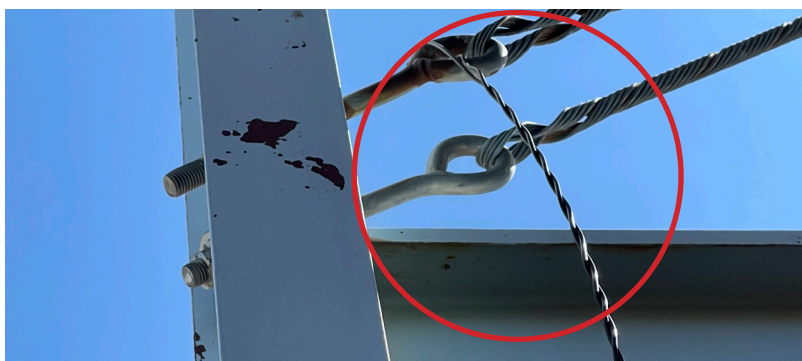
Cross bracing cable is coming undone in several locations.

View of cross bracing cable

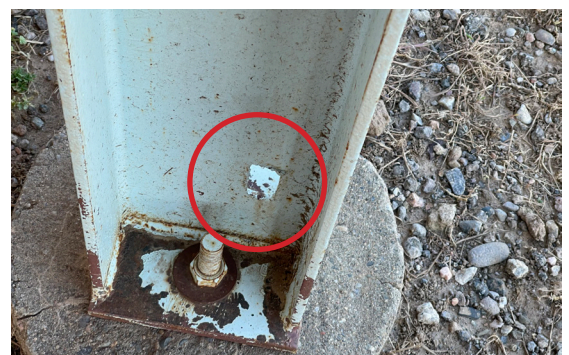
Torch cut cable cross bracing with missing cross bracing.

View of missing cross bracing

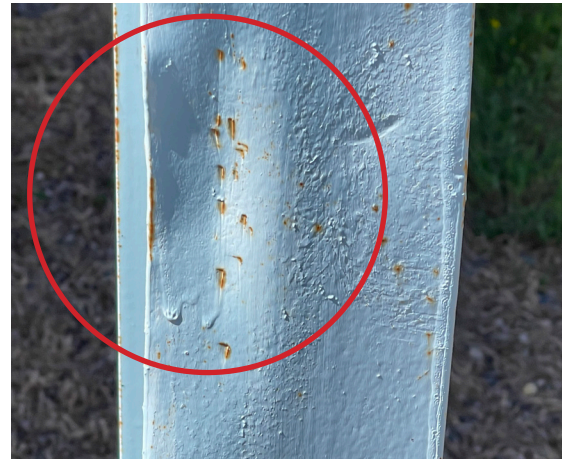
Local column flange buckling of an exterior column. The cause of the buckling appears to be caused by something colliding with the column. Possibly during construction or transportation. This reduces the compressive and bending strength of the column.

View of column buckling

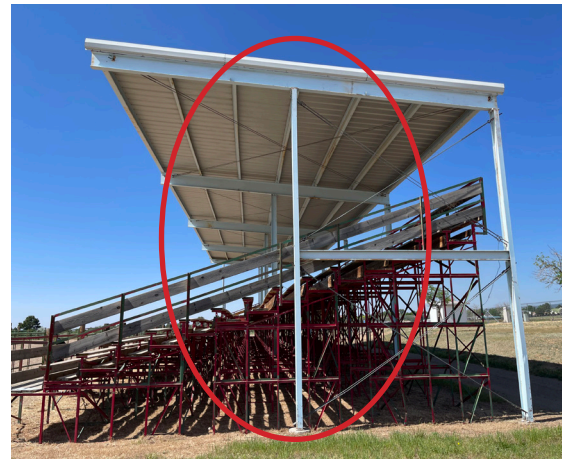
This column is noticeably curved from the foundation to the middle of the column where it is braced and curved in opposite direction from brace location to roof location. This indicates either damage of the column during transportation to this site and assembly, or indicates that the structure has deformed since it was initially erected.

View of bending column

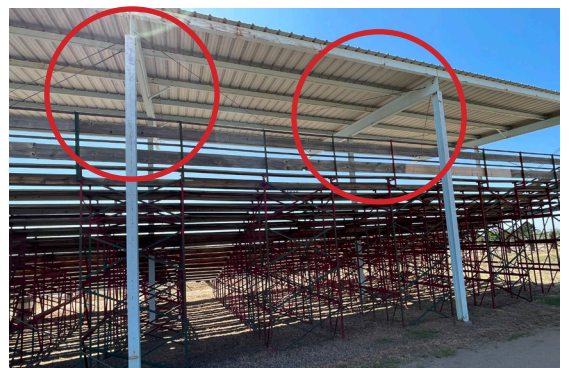
It was apparent that these beams were experiencing lateral web bending. There shouldn't be any web bending out of plane. Stiffeners or lateral beams should have been used to reduce the risk of that happening.

View of lateral web bending

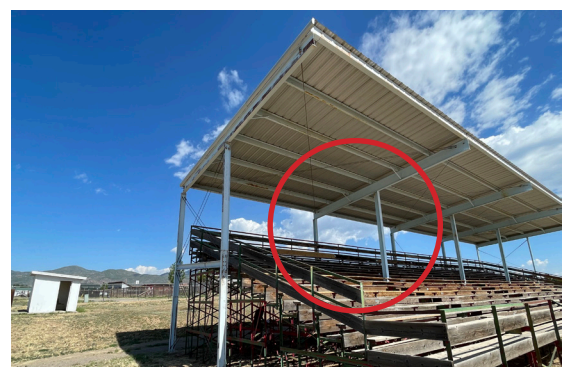
Cross bracing cables are missing from this bay. It would be expected to see symmetrical cross bracing. Only one of the four bays in the rear of the Pavilion structure has cross bracing. It would be expected that two or four would be cross braced.

View of missing cross bracing cables

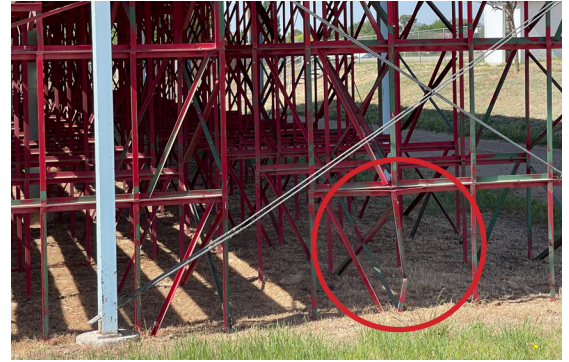
Example of buckled column in Grandstand structure. There are several vertical, diagonal, and horizontal members have buckled. It is difficult to determine if the buckling is due to damage that occurred during transportation and construction or due to structural loading beyond the capacity of the members. Regardless of the cause these buckled structural members have failed and are no longer capable of doing what they were designed to do.

View of buckled column

The Grandstand structure is in very poor condition and should not be used by anyone. The Grandstand structure should be replaced completely.

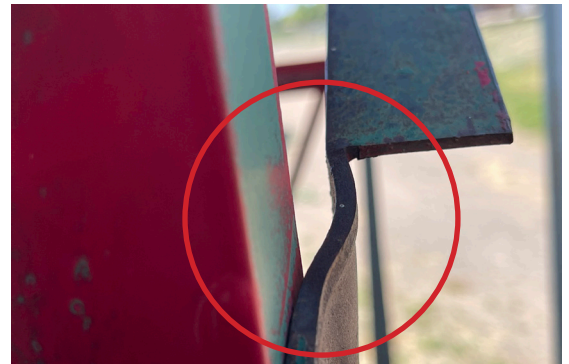
This is an example of several places where one angle leg has been coped off the structural member at the connection. It is evident that the connection has buckled in compression. There should not be any buckling of any portion of these members. There were several of these connection failures that were seen.

View of buckled connection

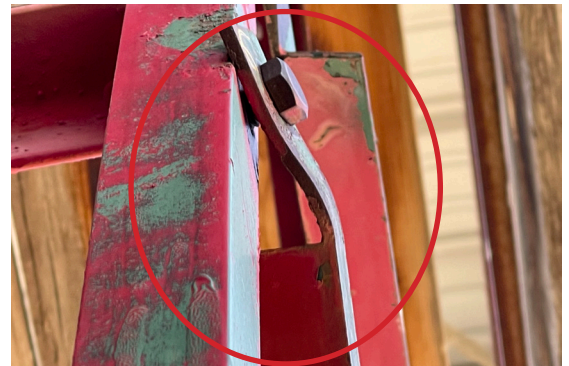
This is an example of another Grandstand structural member connection failure. The coped angle is bending out of plane and the bolt appears to be coming loose. There are several of these connection failures that were seen.

View of failed connection

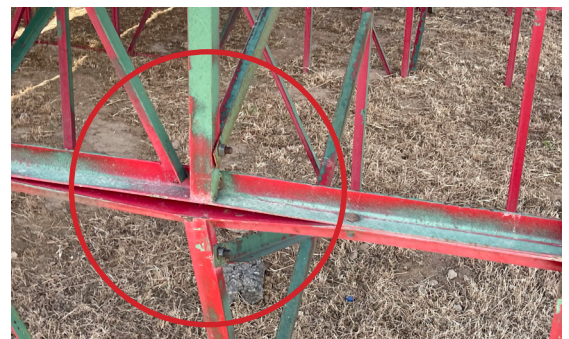
This is an example of local prying failure due to buckling of lower vertical member.

View of prying failure

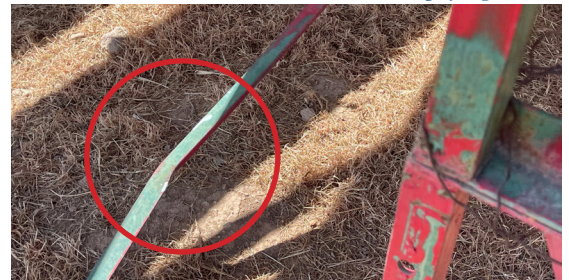
This is an example of a diagonal structural member buckling failure. There were several of these types of buckled members seen throughout the Grandstand structure.

View of structural member buckling failure
